Norwegian
Public Roads Administration

Road Safety measures in respect of MC at Route 32 - Vision zero

Pictures from before and after measures are carried out

Telemark County Roads Office

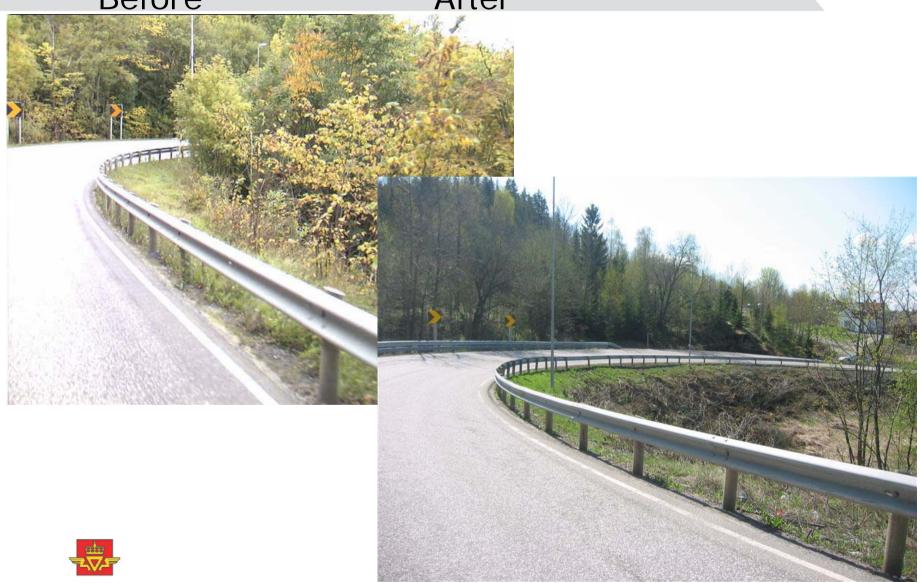
Problem: Pour visibility on curve and hazardous

elements in the safety zone

Measure: Remove trees, move columns to the inside,

move mailbox to the entrance

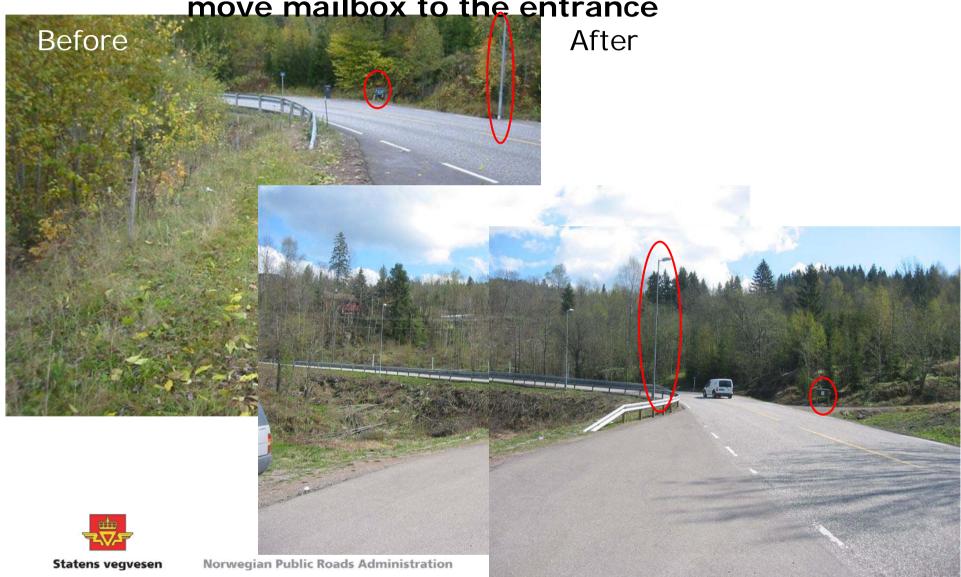
Problem: Unprotected guardrail posts in the outside of a curve Solution: MC guardrail of polyethylene (from Hallingplast A/S)

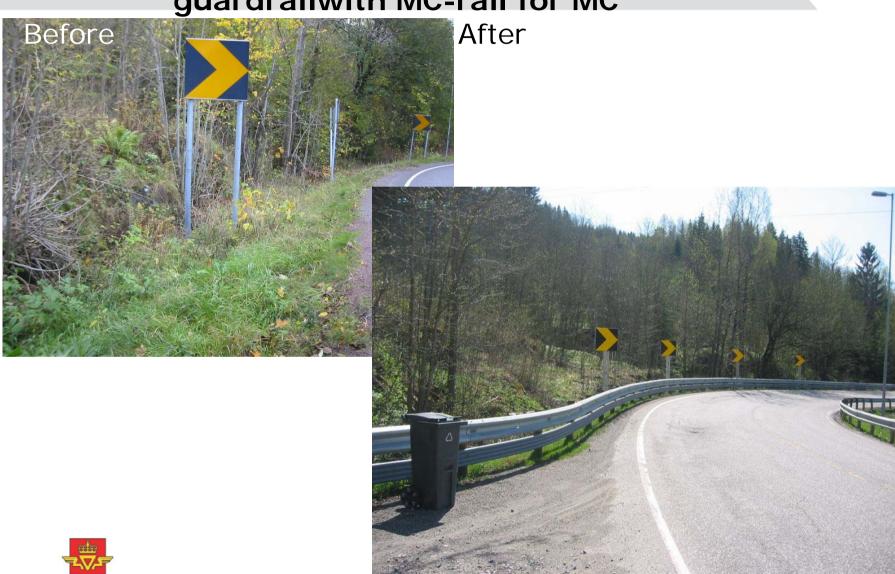
Problem: Hazardous signing columns

Measure: Passive safety masts for vehicles and

guardrailwith MC-rail for MC

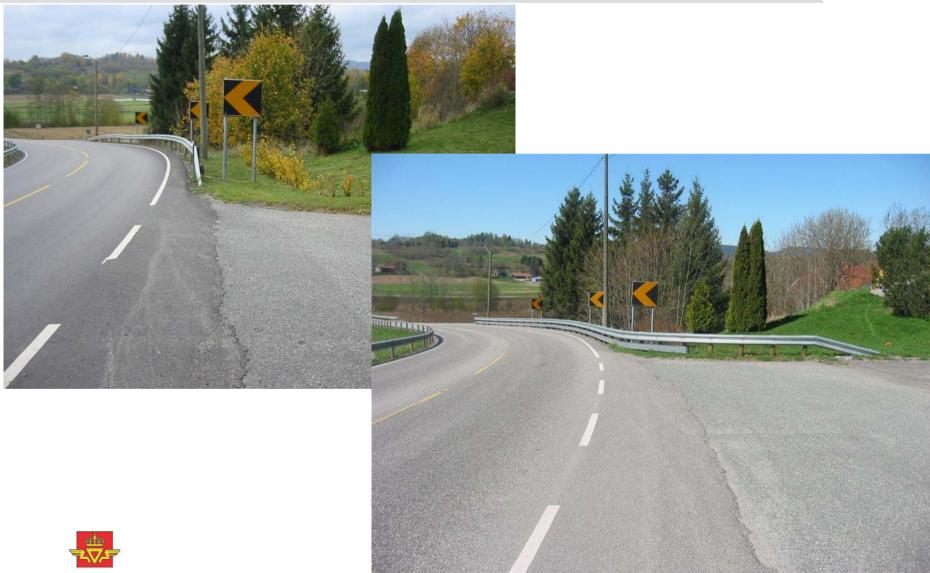
Problem: Faulty guardrail terminal

Measure: Extend guardrail and swing it into the entrance

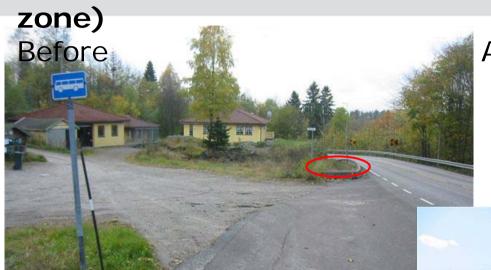
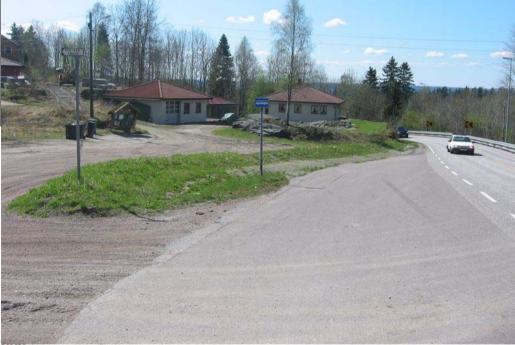
Problem: Pour visibility from the entrance to the curve

Measure: Move the entrance far away from the curve

(Remove concrete elements from the safety

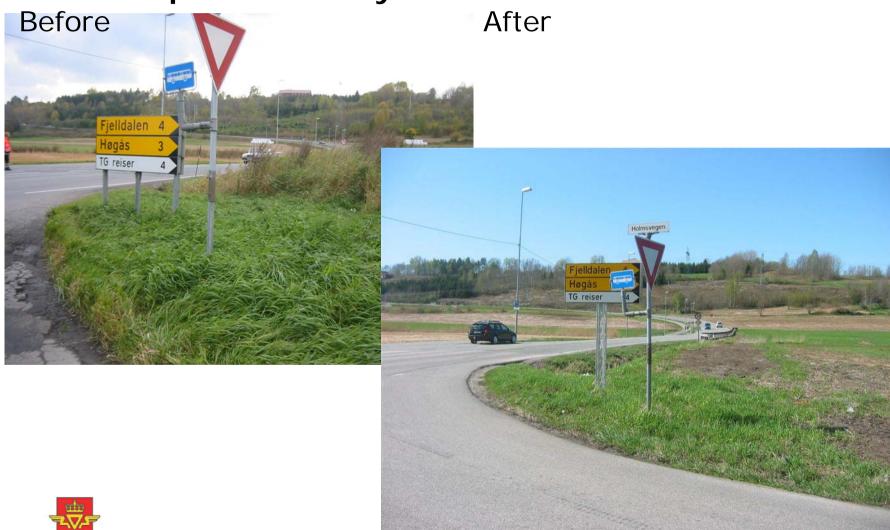
Problem: Pour visibility at junction

Measure: Remove vegetation and lower the terrain

New signs are raised and mounted on a

passive safety mast

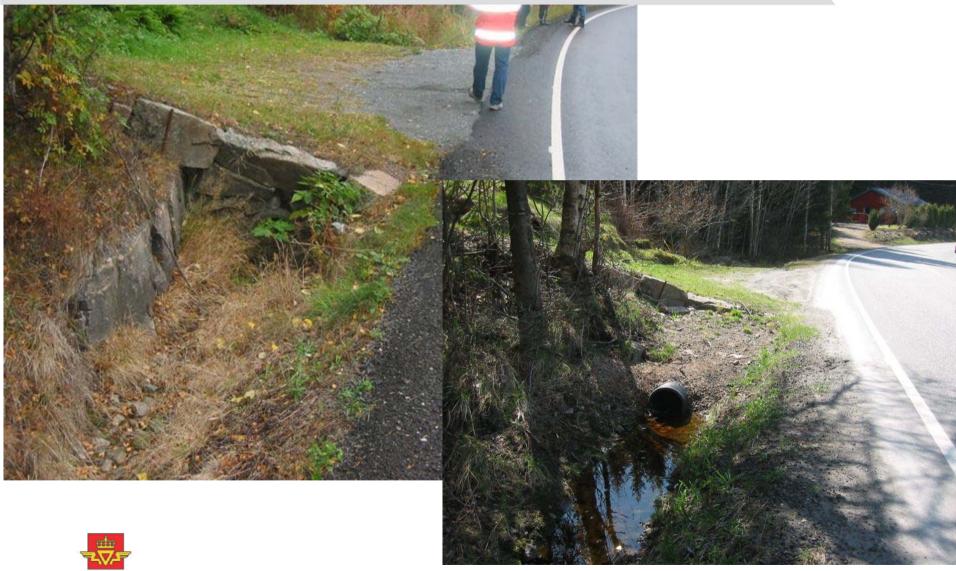
Problem: Hazardous change from the ditch to the entrance

Measure: Extend the subdrain and slacken the profile

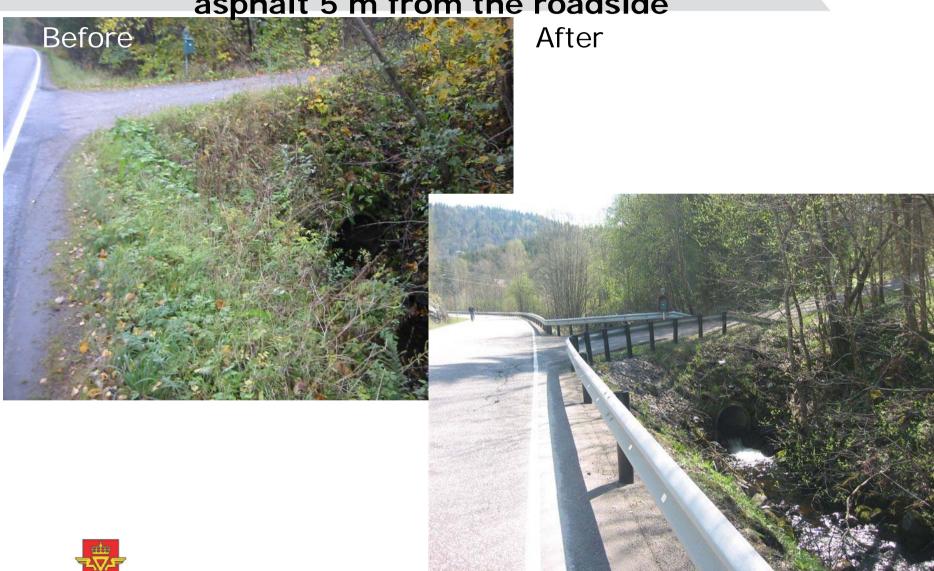
Problem: Deep ditch and gravel from the entrance

Measure: Guardrail bent into the entrance and

asphalt 5 m from the roadside

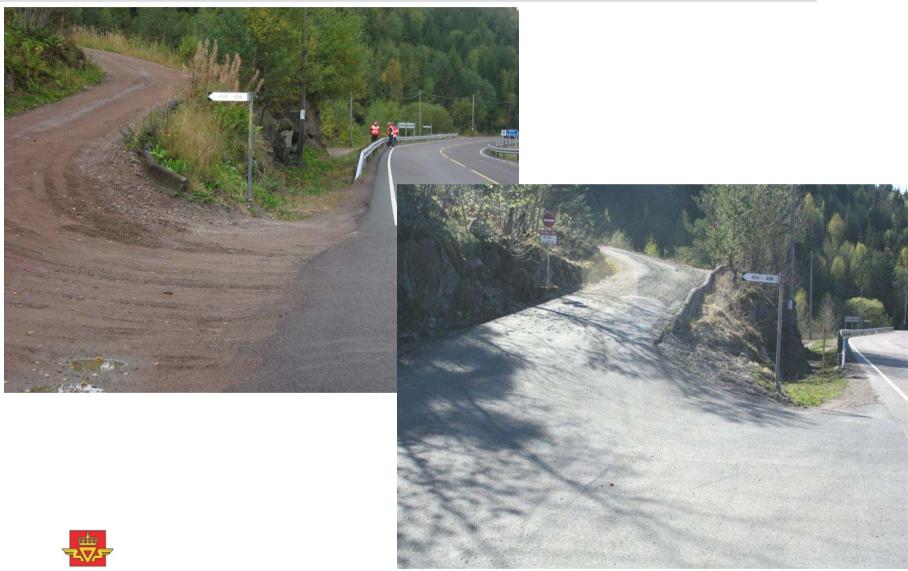
Problem: Gravel from the entrance

Measure: Asphalt 5 m from the roadside

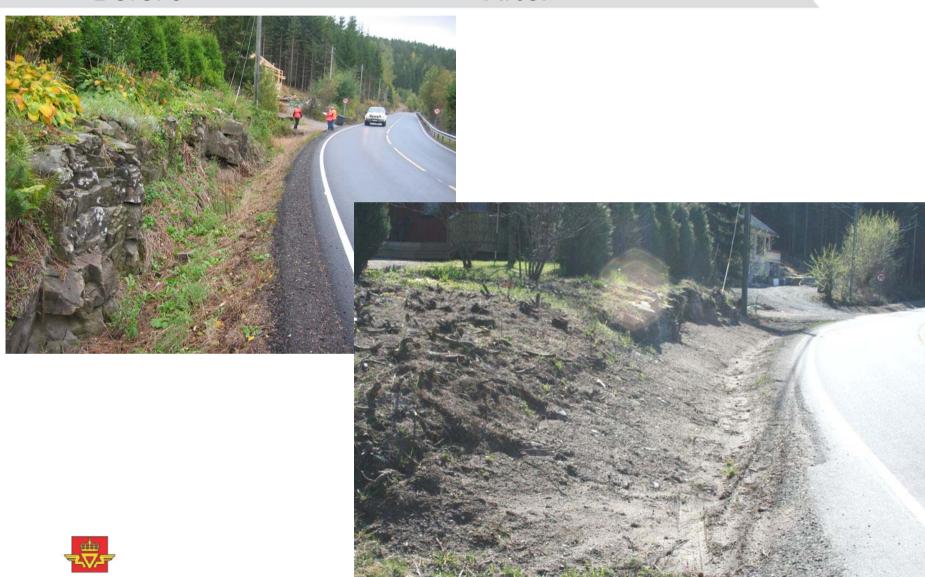
Problem: Rocks within the safety zone

Measure: Crush rock and fill up against rock face

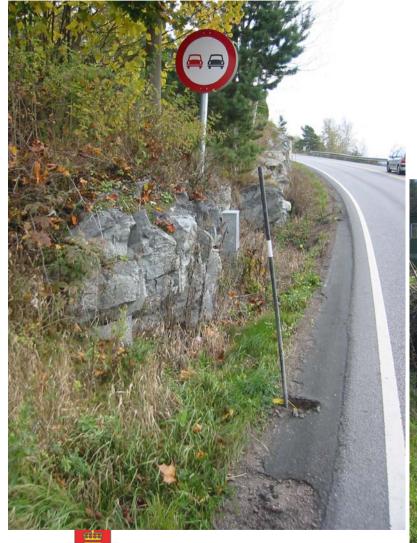
Problem: Protruding rock within the safety zone Measure: Crush the rock

For the future: Remove the cabinet from the ditch.

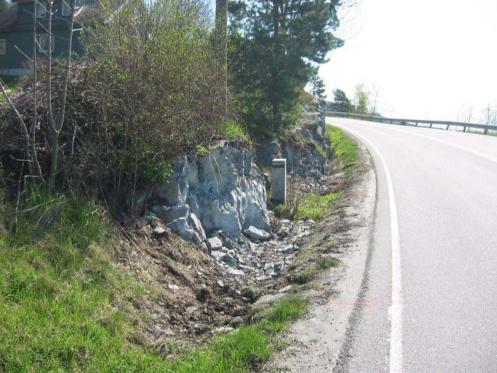
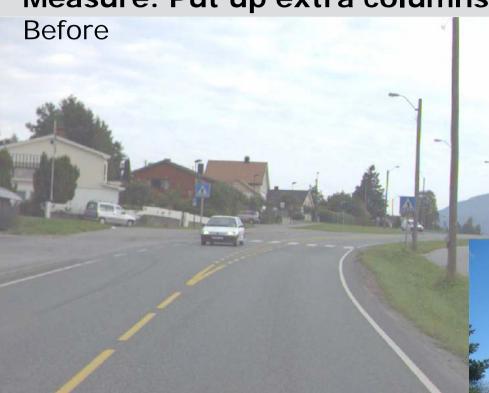
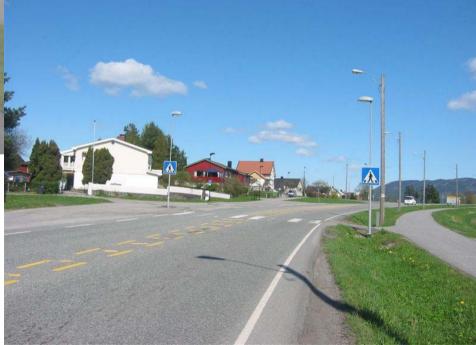
Problem: Pour visibility of pedestrians when crossing in the dark with ordinary road lighting in the curve

Measure: Put up extra columns for highlighting the crossing

Measure: Highlighting the pedestrian crossing with white light and achieving a high level of vertical illuminance; to make pedestrians visible to oncoming drivers.

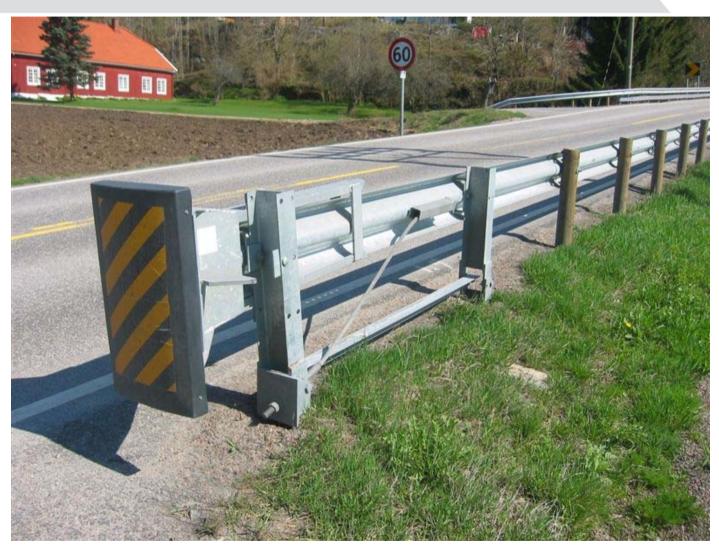
Problem: Faulty guardrail terminal

Left: Extend the guardrail, swing it into the entrance,

bring it down and anchor it.

Right: Extend the guardrail, swing it over the ditch and

anchor it in the slope.
