The Dynamics Of Motorcycle Crashes

A Global Survey of 1578 Motorcyclists

February 2020

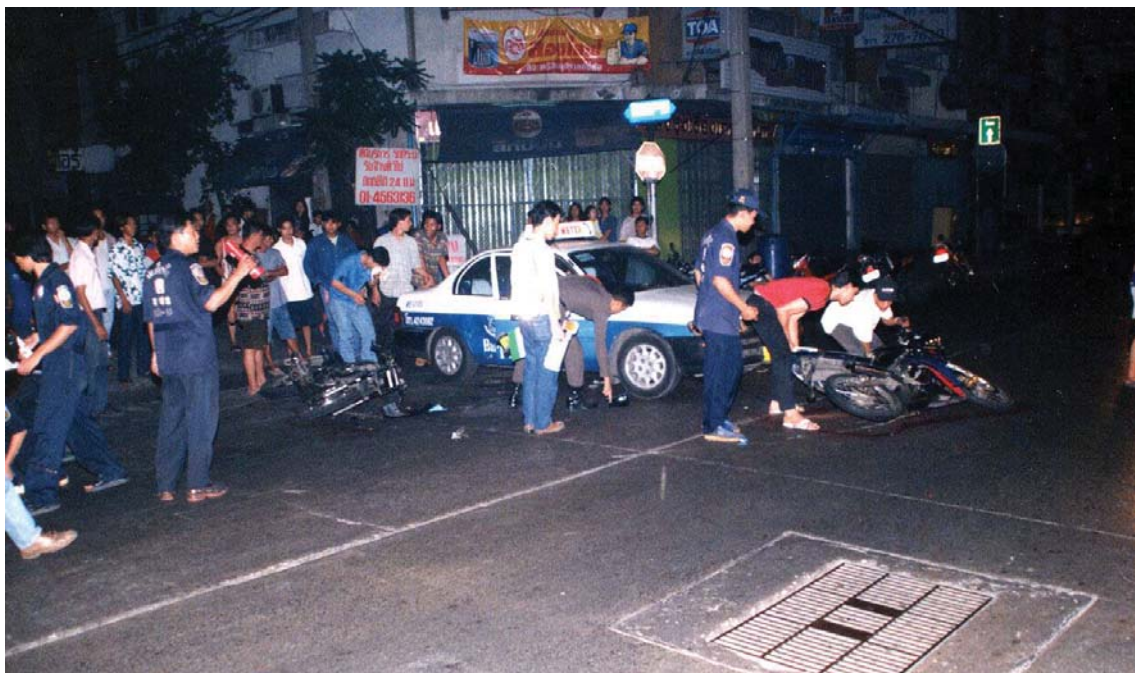
Figure 14 shows how a Bangkok taxi driver succeeded in causing two motorcycles approaching from his right to crash when he exited a side street onto a larger roadway. The riders collided with each other while trying to take evasive action, then both fell and slid. One motorcycle hit the taxi right rear door, the other slid to a stop in front of the taxi. Bangkok post-crash accident scenes were often a little chaotic.

Figure 14: Crash in Bangkok, Taxi vs. PTW

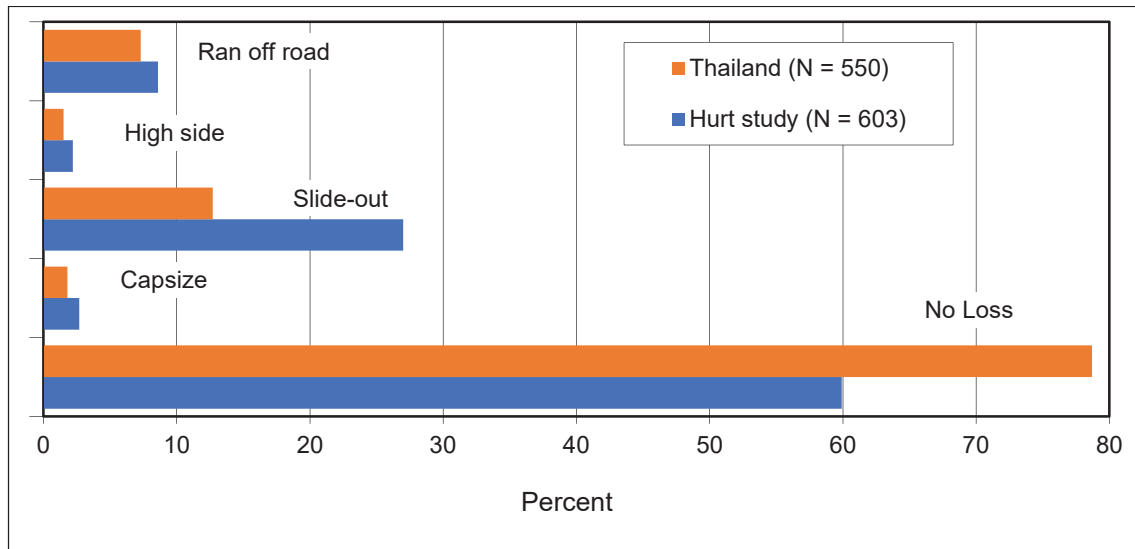
Figure 17: Loss of control mode for riders in the Thailand and Hurt studies who took evasive action before they crashed⁴. "Capsize" is a simple low-speed fall over without any skidding

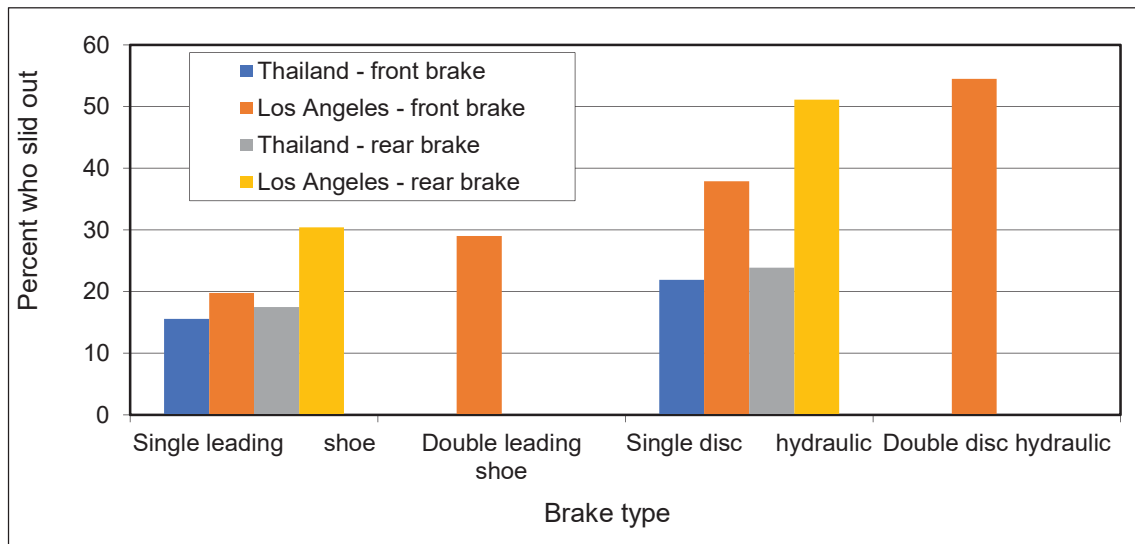
Figure 18: Frequency of slide-out loss of control as a function of the type of brake in Thailand and the Hurt study (Ouellet & Kasantikul, 2006)

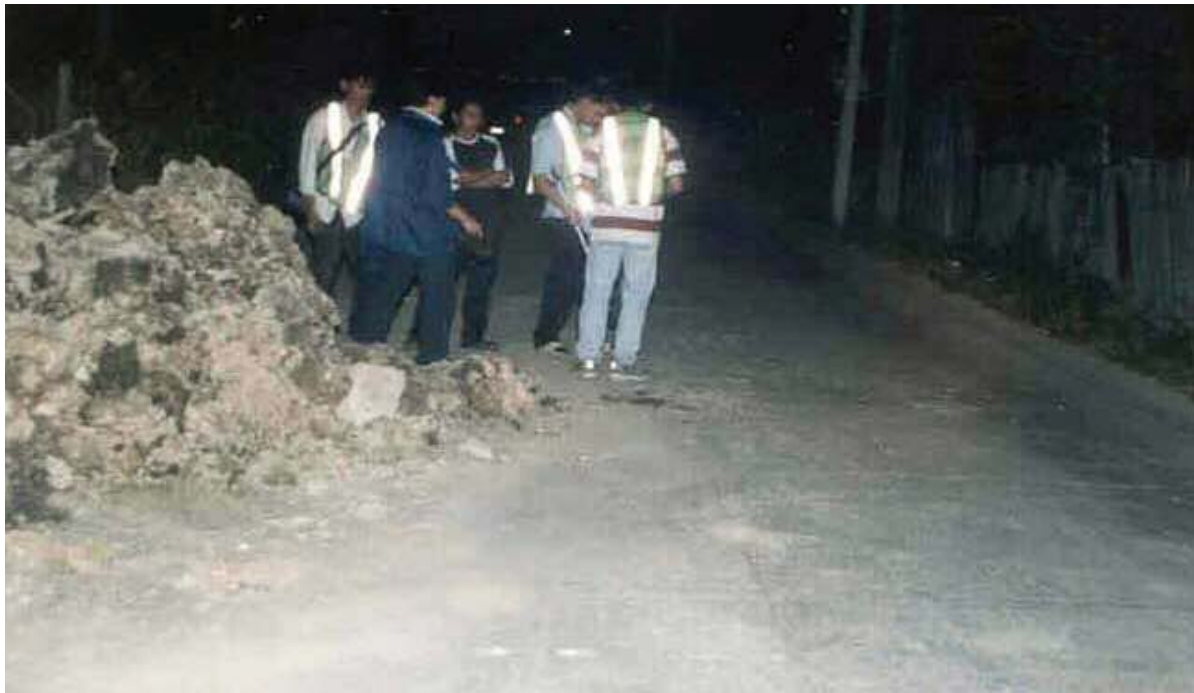
Figure 19: Thailand investigators at the scene of an upcountry crash. The rider hit a huge unmarked pile of dirt that covered half the roadway. Adequate warnings of roadway hazards were not always a strong point of Thailand work projects.

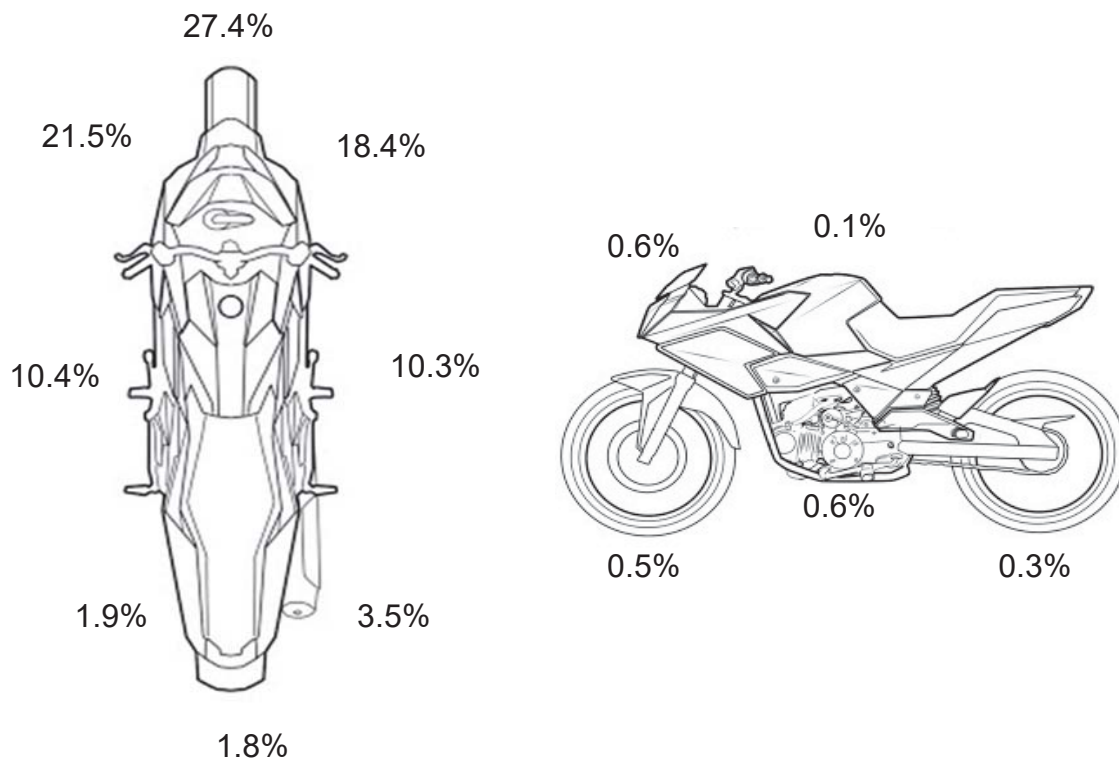
Figure 21 illustrates the portion of the motorcycle where the primary impact occurred. Two-thirds of the impacts occurred at the front, right front or left front of the motorcycle. "Left center" (10.4%) or right center (10.3%) could include impacts in which another vehicle struck the motorcycle in the side or crashes in which the motorcycle simply fell on its side at any speed—that could include low-side and high-side crashes.

Figure 21: Location of impact to the motorcycle

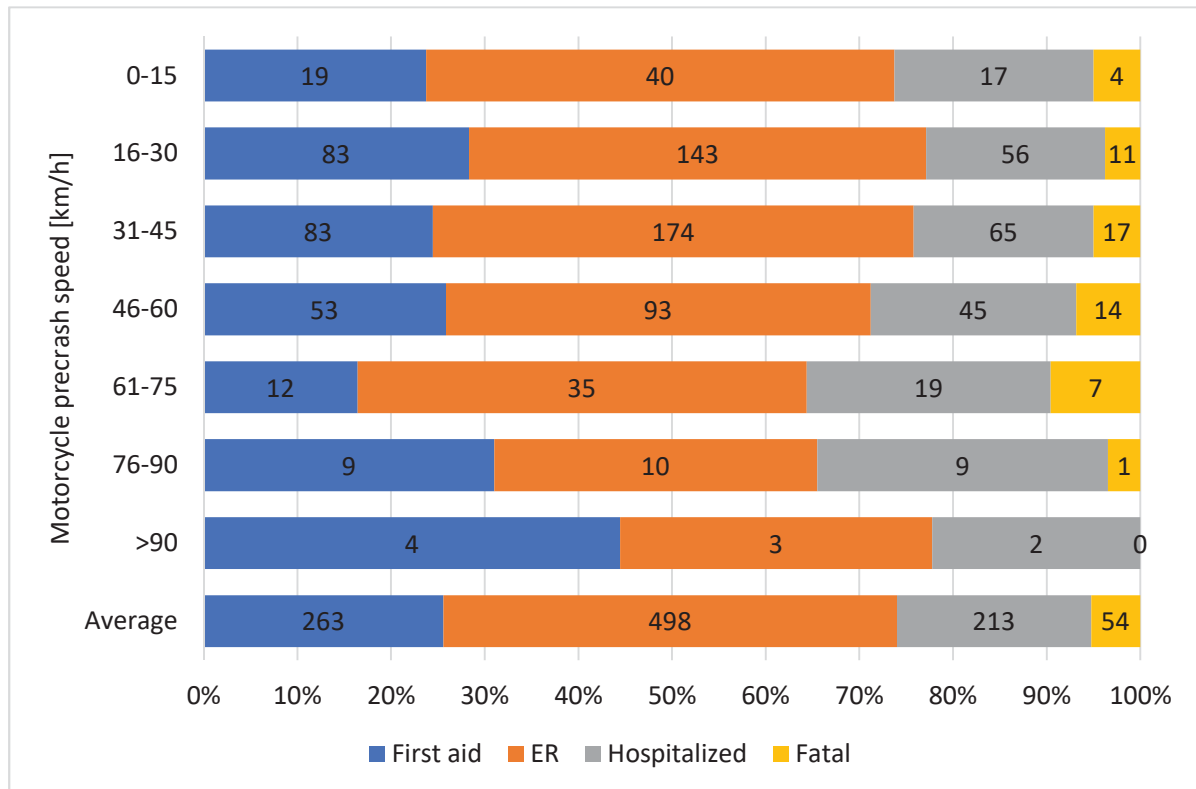
The relationship between motorcycle speed and rider injury severity appears to be real but not particularly strong. As astronauts and Mars surface exploration vehicles show, the crucial factor is not how fast you go, it's how you come to a stop.

Figure 23: Motorcycle pre-crash speed and rider post-crash medical treatment

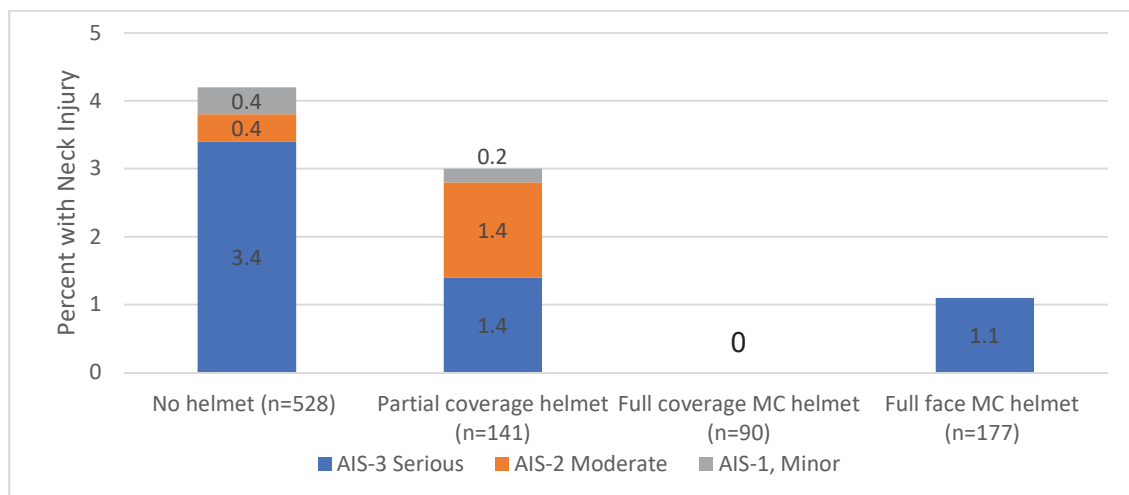
A really poorly done 1986 paper reanalyzed Hurt study data and alleged that the risk of neck injuries increases at speeds over 13 mph. Unfortunately, the author of that paper used the wrong variable for speed and therefore had to "impute" a speed value for 100% of the un-helmeted riders and about 90% of the helmeted riders. (The paper mentions "imputing" missing values but fails to admit the vast extent of such imputing.) Rice et al., (2016) exposed the failings of the 1986 paper and reanalyzed the same Hurt study database correctly.³⁹ Rice et al. found what the Hurt report found: a very mild reduction of neck injuries among riders who were wearing a helmet when they crashed.

Figure 26: Neck injury severity as a function of the amount of head coverage provided by the rider's helmet

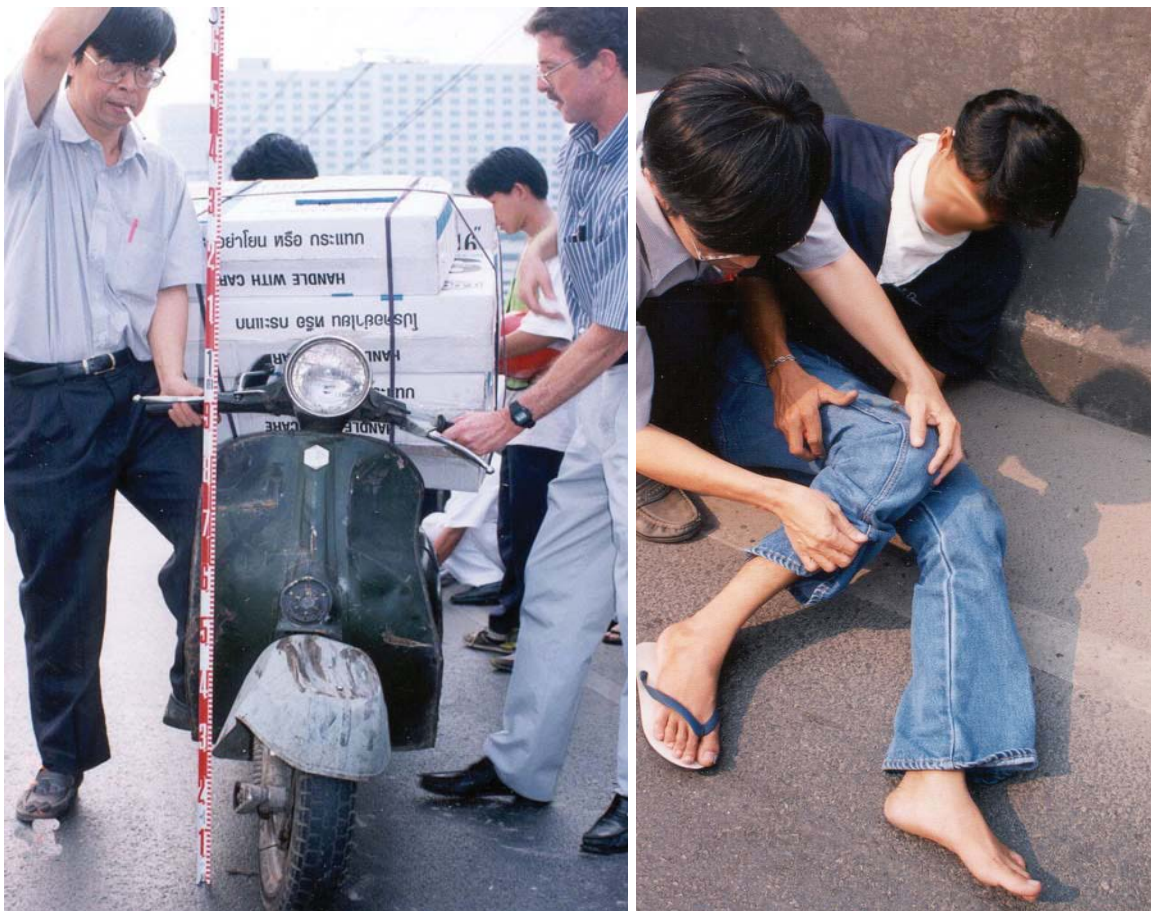
Typical rider apparel for cool season in Bangkok: blue denim pants, flip-flop footwear and lightweight upper torso coverage. In hot season, upper torso coverage would probably be T-shirt only. Dr Vira checking the rider's injuries: No fractures or dislocation but a badly bruised knee.

Figure 27: Practical research in Thailand

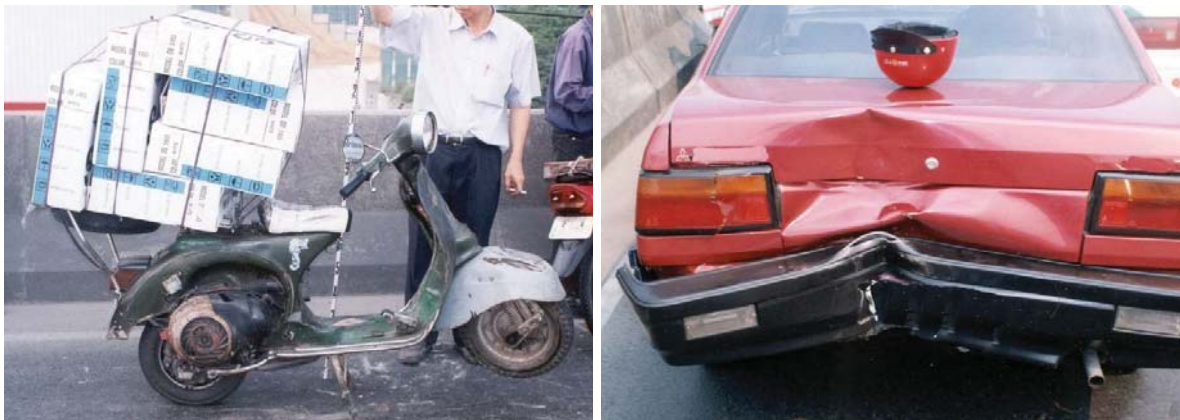
More photos of the same crash can be found in Figure 28: Scooter front fender and front end damaged by impact with car rear end. The load of boxes was common for delivery riders. Rear end of the car struck by the scooter. The helmet resting on the rear of the car was typical of those worn in Thailand.

Figure 28: PTW and the rear end of the car

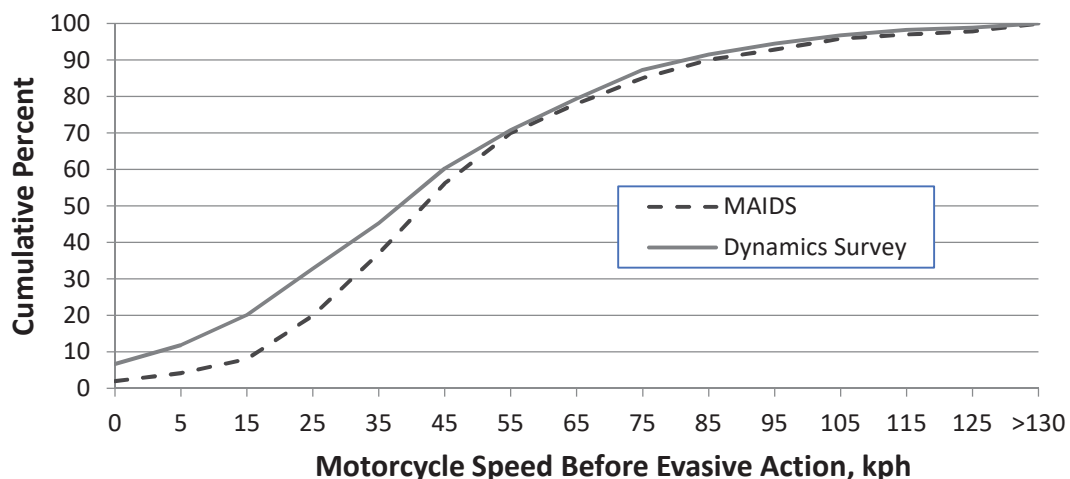
Though the two studies differ in how the number was reached, both MAIDS and the Survey report motorcycle speed before any evasive action. These estimates were remarkably similar as shown in Figure 37. SW did not report motorcycle speed at impact or before any evasive action. A graph line further to the right indicates higher speeds for riders in that group. Numbers on the horizontal axis represent the mid-point of a 10 kph speed range.

Figure 37: Cumulative percent distribution of motorcycle speed before evasive action in MAIDS study and the Dynamics Survey.
